## **NIOSH HEALTH HAZARD EVALUATION REPORT:**

**HETA #2002-0347-2910**

**Ocean Bank**

### Evaluation of Magnetic Fields at Ocean Bank

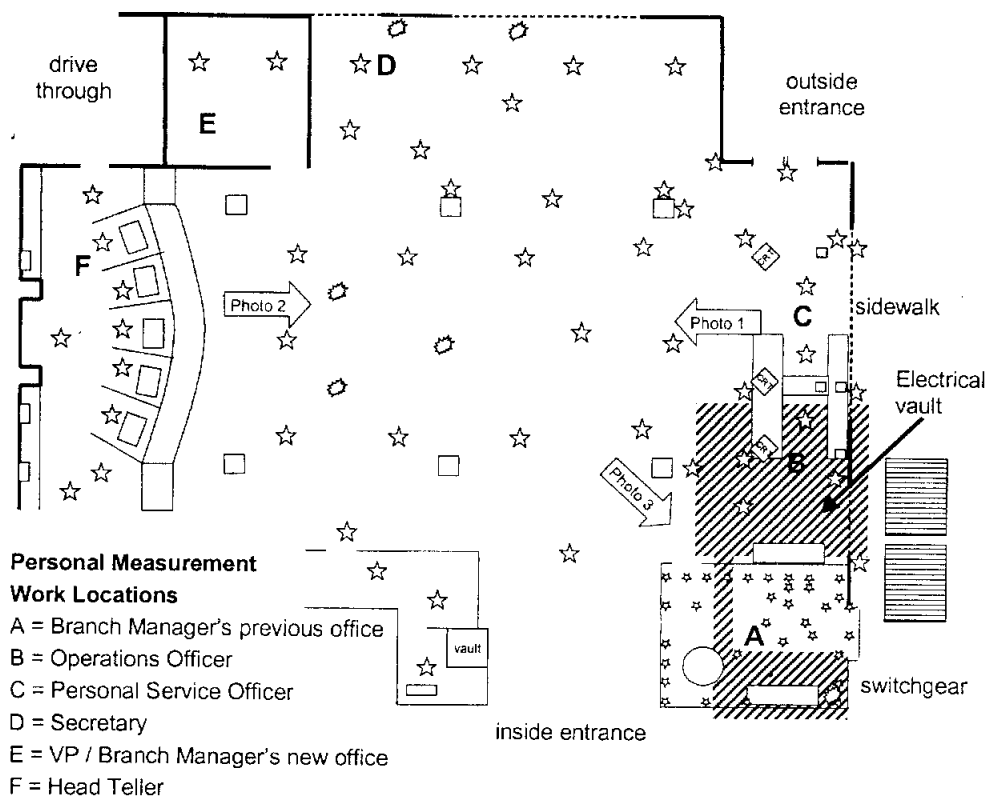
**Figure 1.** Ocean Bank Floor Plan. Area and personal magnetic field measurement locations. August 15, 2002.

The Operations Officer work location is designated as “B” on Figure 1. This work location is nearest the previous location of the Branch Management office and is also directly above the electrical vault. Area magnetic field measurements (40 inches above the floor) in this general work area ranged between 16 mG and 125 mG. The job activities on the day of measurements required that the Operations Officer float from the normal work location to other

Branch Management office which is above the electrical vault and switchgear equipment (Figures 1 and 2).

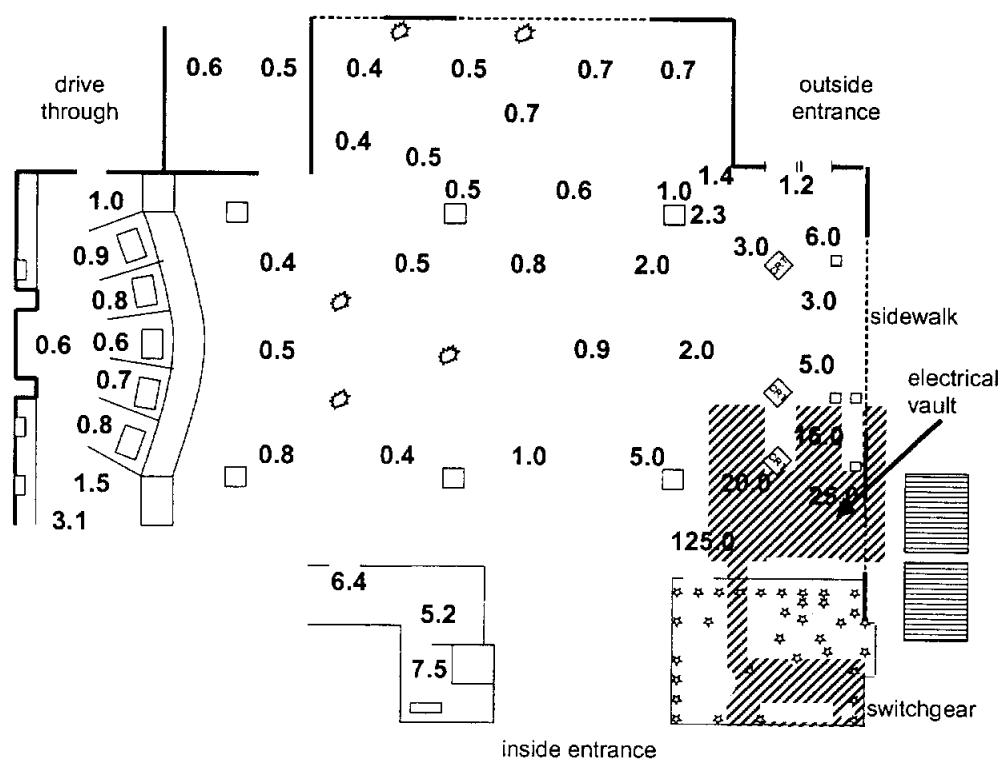
**Figure 2.** Ocean Bank Floor Plan. Area magnetic field measurement results (milligauss, mG). August 15, 2002. All measurements were obtained about 40 inches from the ground.

The exposures measured outside the Branch Management office ranged between 0.4 and 125 mG (Figure 2). The highest exposures were measured nearest the Branch Management office which is also located above one of the two electrical vaults servicing this building. The vault below the office is the original vault to the building and the other vault is located on another floor within the building, contributing no EMF exposures within the Ocean Bank.

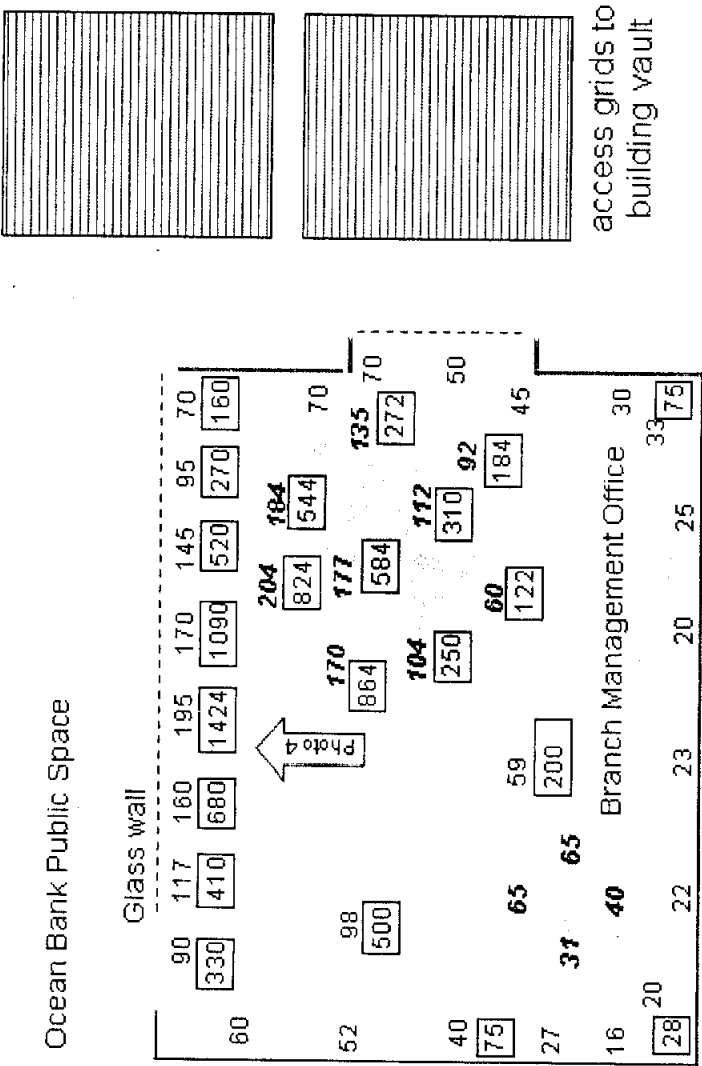
Figure 3. Ocean Bank, Branch Management Office magnetic field measurement results. August 15, 2002. HETA #20020347.

The exposures measured inside the Branch Management office ranged between 16 and 1,424 mG (Figure 3). The highest exposures were measured at the floor level and followed a pattern consistent with the location of the electrical vault and the connection line to the switchgear equipment.

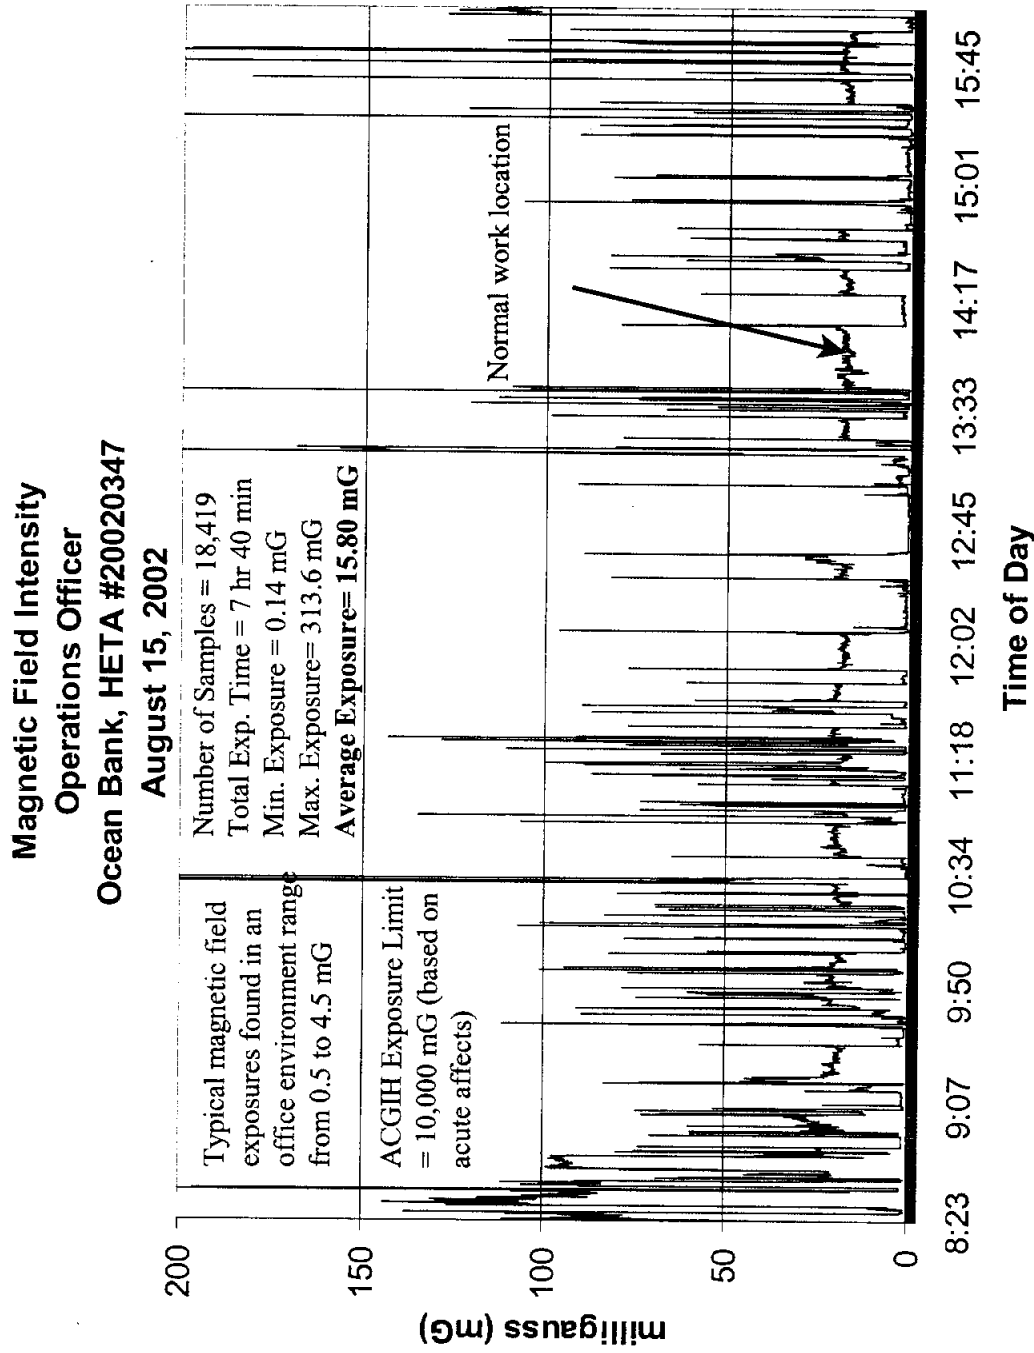
**Figure 4.** Time-magnetic field intensity relationship for Operations Officer. Work location is designated as B on Figure 1.

locations throughout the bank. The movement patterns during the monitoring period (7 hours and 40 minutes) are illustrated in Figure 4. The average personal magnetic field measurement was 15.8 mG, ranging between 0.14 mG and 313.6 mG. The personal exposure profile shows that the area and personal magnetic field measurements correlate when the worker was at the normal work station.

3. The measured exposure was highest for the Operations Officer who spent more time near the electrical vault. It should be noted that the movement patterns of the Operations Officer will have a significant impact on the average daily exposure to magnetic field intensities. On the day of the measurements, the average magnetic field exposure was 15.8 mG, which is virtually the same as the desk measurement of 16.0 mG. This suggests that the worker either spent their entire workday at their work station, or their time was spent in areas of higher or lower magnetic field intensities resulting in an average exposure about the same as the area measurement. The movement patterns of this worker can be identified via the magnetic field exposure profile illustrated in Figure 4. This figure illustrates that the worker did move throughout the bank during the day. Relative to the other work locations, this work station and the old Branch Management work station are better suited for jobs that are not stationary, since any movement away from these areas would result in lower magnetic field exposures. Even with the movement patterns of the Operations Officer, the average magnetic field exposure was 3.5 to 31.6 times higher than the typical magnetic field exposures found in an office environment.

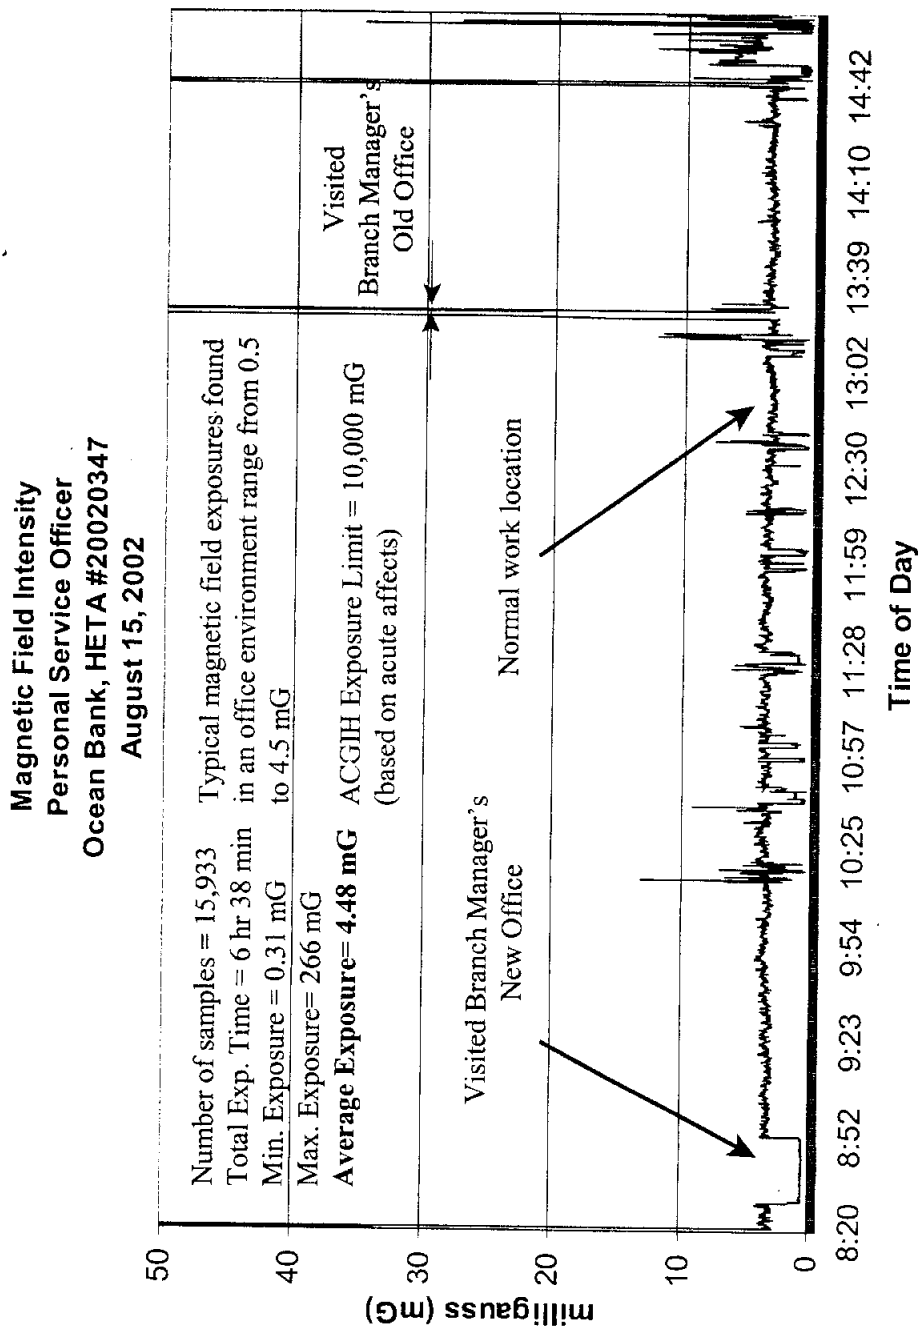
**Figure 5.** Time-magnetic field intensity relationship for Personal Service Officer. Work location is designated as C on Figure 1.

The Personal Service Officer work location is designated as “C” on Figure 1 and is near the public entrance. Area magnetic field measurements (40 inches above the floor) in this general work area ranged between 0.7 mG and 1.4 mG. The Personal Service Officer activities were completed primarily at this work location and resulted in an average personal exposure of 4.48 mG, ranging between 0.31 mG and 266 mG. The movement patterns during the monitoring period (6 hours and 38 minutes) show that the area and personal magnetic field measurements correlate with the worker’s normal work station (Figure 5).

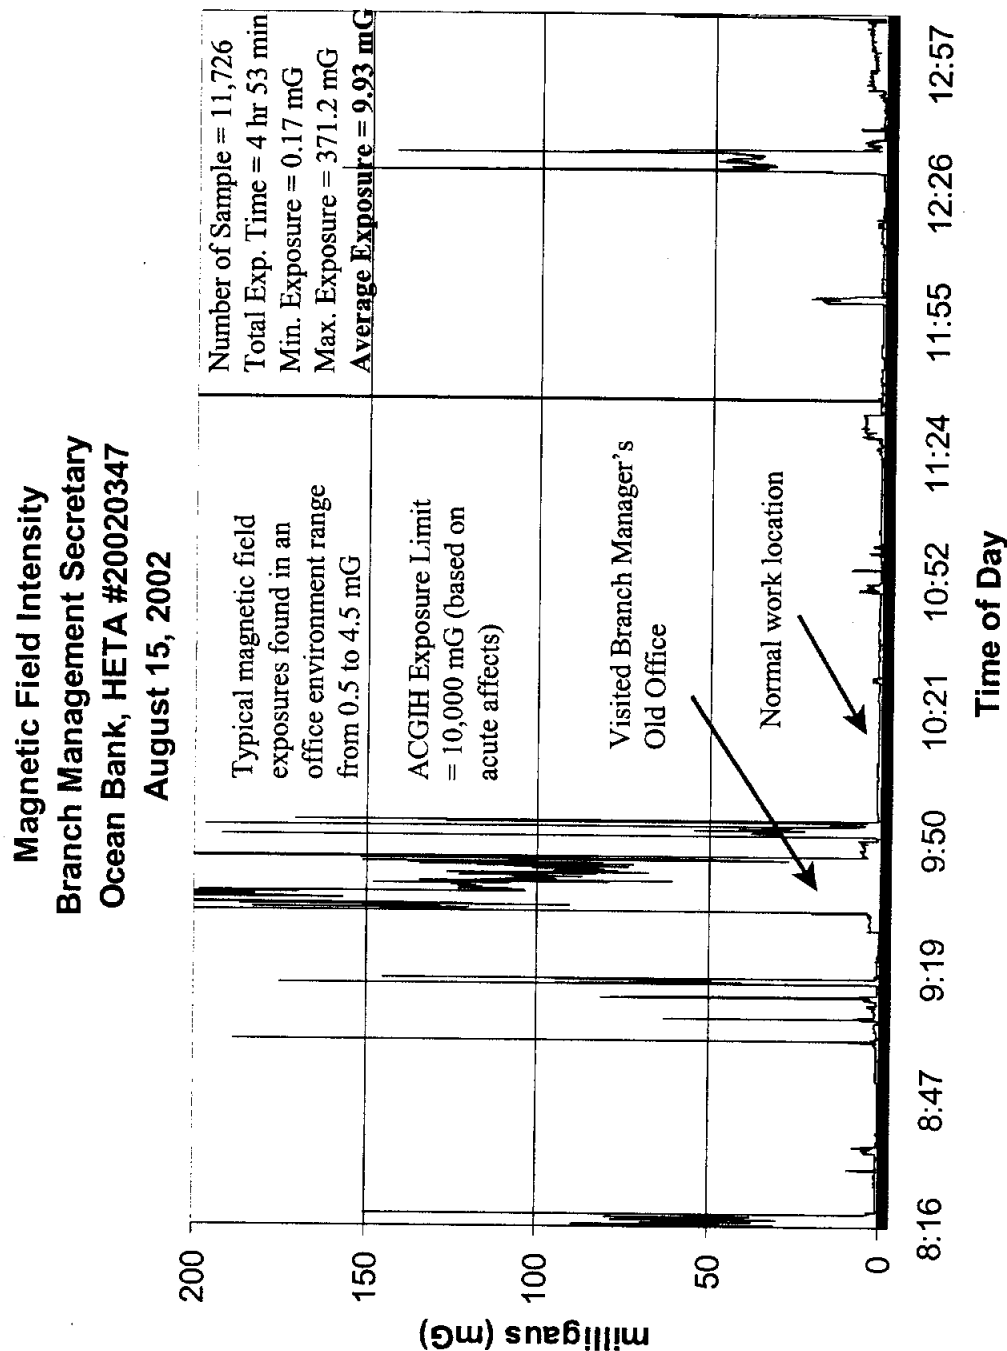
**Figure 6.** Time-magnetic field intensity relationship for Branch Management Secretary. Work location is designated as D on Figure 1.

The Branch Management Secretary work location is designated as “D” on Figure 1. Area magnetic field measurements (40 inches above the floor) in this general work area ranged between 0.4 and 0.5 mG. The Branch Management Secretary activities were completed primarily at this work location and resulted in an average personal exposure of 9.93 mG, ranging between 0.17 mG and 371.2 mG. The movement patterns during the monitoring period (4 hours and 53 minutes) show that the area and personal magnetic field measurements correlate with the worker’s normal work station (Figure 6). During periods of high magnetic field exposures (9:30 to 10:00 a.m.), this individual met with the NIOSH investigator in the vacated Branch Management office. Other periods with smaller but elevated magnetic field exposures resulted from the worker’s movement in or around the vacated Branch Management office.

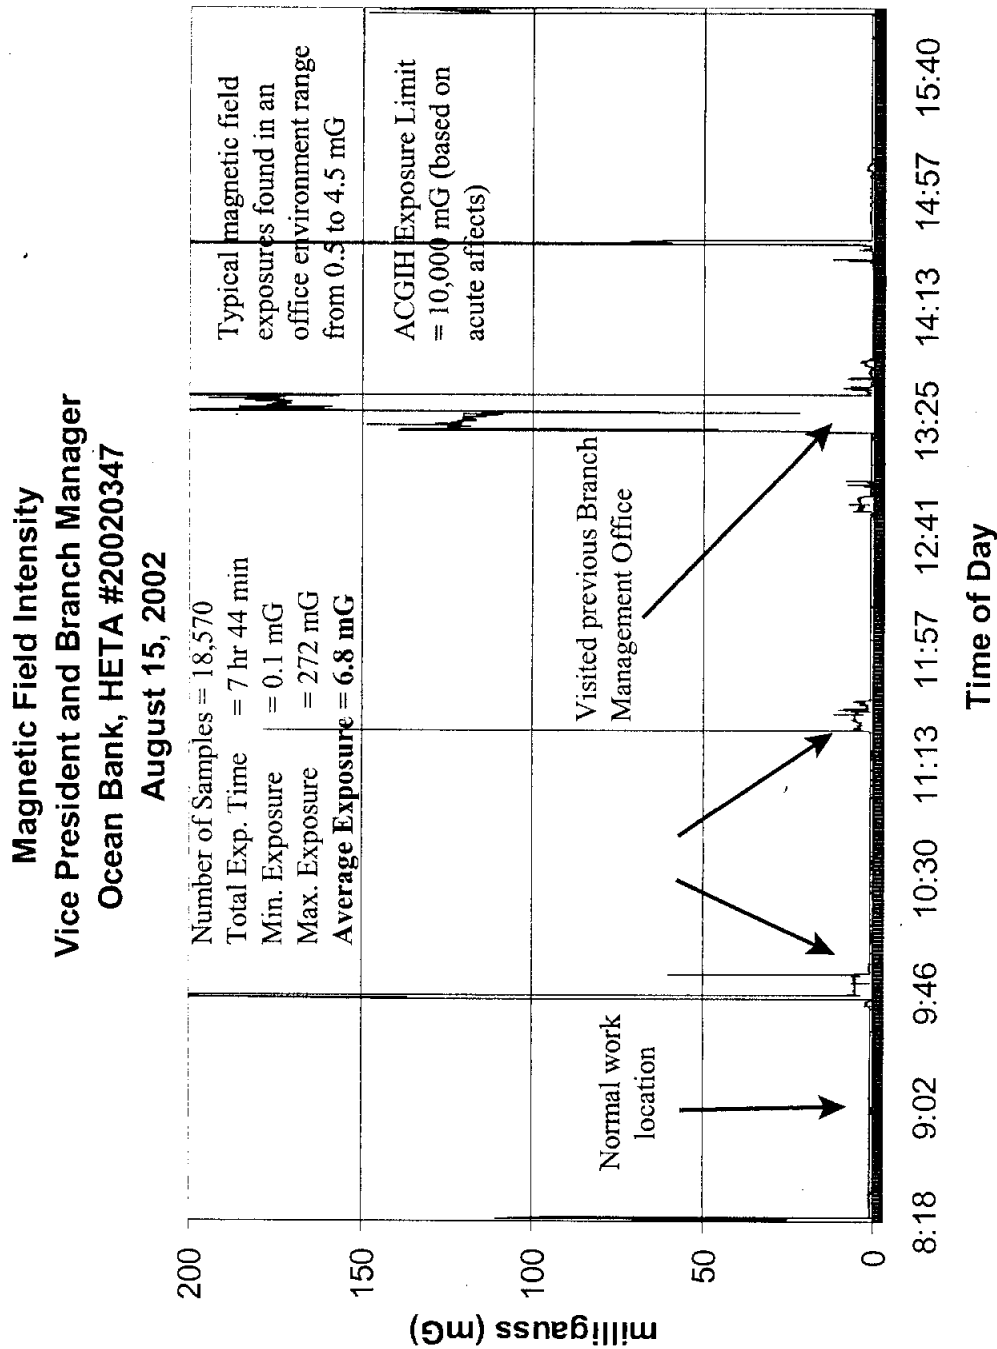
**Figure 7.** Time-magnetic field intensity relationship for Vice President and Branch Manager. Work location is designated as E on Figure 1.

The Vice President and Branch Manager work location is designated as "E" on Figure 1. Area magnetic field measurements (40 inches above the floor) in this general work area ranged between 0.5 and 0.6 mG. The work activities were completed primarily at this work location and resulted in an average personal exposure of 6.8 mG, ranging between 0.1 mG and 272 mG. The movement patterns during the monitoring period (7 hours and 44 minutes) show that the area and personal magnetic field measurements correlate with the worker's normal work station (Figure 7). During periods of higher magnetic field exposures, this individual met with the NIOSH investigator in the vacated Branch Management office. Other periods with smaller but elevated magnetic field exposures resulted from the worker's movement in or around the vacated Branch Management office.

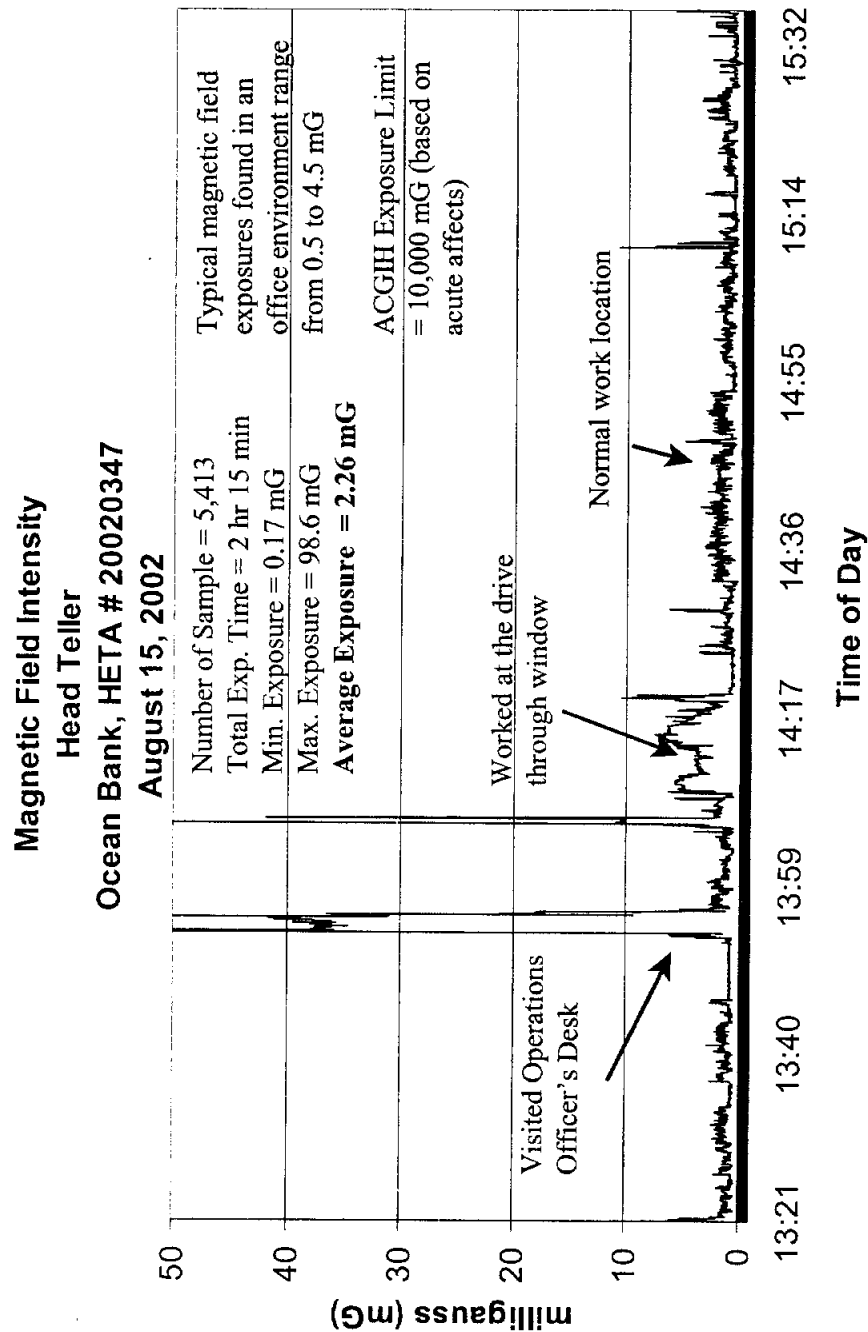
**Figure 8.** Time-magnetic field intensity relationship for Head Teller. Work location is designated as F on Figure 1.

location and resulted in an average personal exposure of 2.26 mG, ranging between 0.17 mG and 98.6 mG. The movement patterns during the monitoring period (2 hours and 15 minutes) show that the area and personal magnetic field measurements correlate with the worker's normal work station (Figure 8). During periods of higher magnetic field exposures, this individual met with the Operations Officer near the vacated Branch Management office. Other periods with smaller but elevated magnetic field exposures resulted from the worker's movement in or around the drive-through window office space.

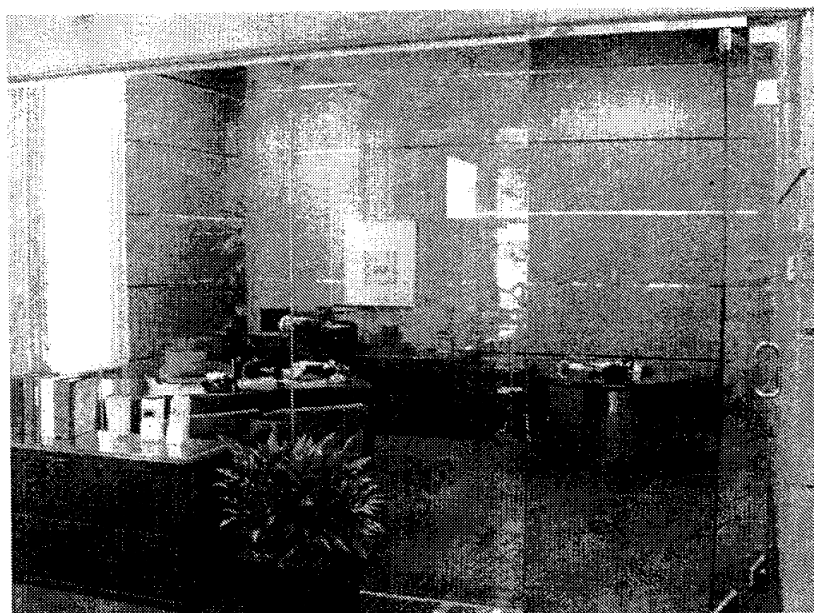
**Photo 3.** View looking into Branch Management Office. The electrical vault that services the building is below this space. August 15, 2002. HETA # 2002-0347.

1. Installing magnetic shielding on the floor of the bank.
2. Increasing the distance from, and reducing the time workers spend in the high magnetic field area by relocating employees to other work areas within the bank. This may result in unused office space which could be regained if the bank entrance was relocated above the electric vault. This recommendation may be more a reliable and cost effective approach toward reducing worker exposures than installing shielding.
3. Requesting FP&L to rewire the vault to reduce magnetic field emissions.
